Geotechnical Summary Report, Rio Oso Flood Risk Reduction Feasibility Project

Geotechnical Summary Report

Rio Oso Flood Risk Reduction Feasibility Project

Sutter County, CA
December 2, 2019

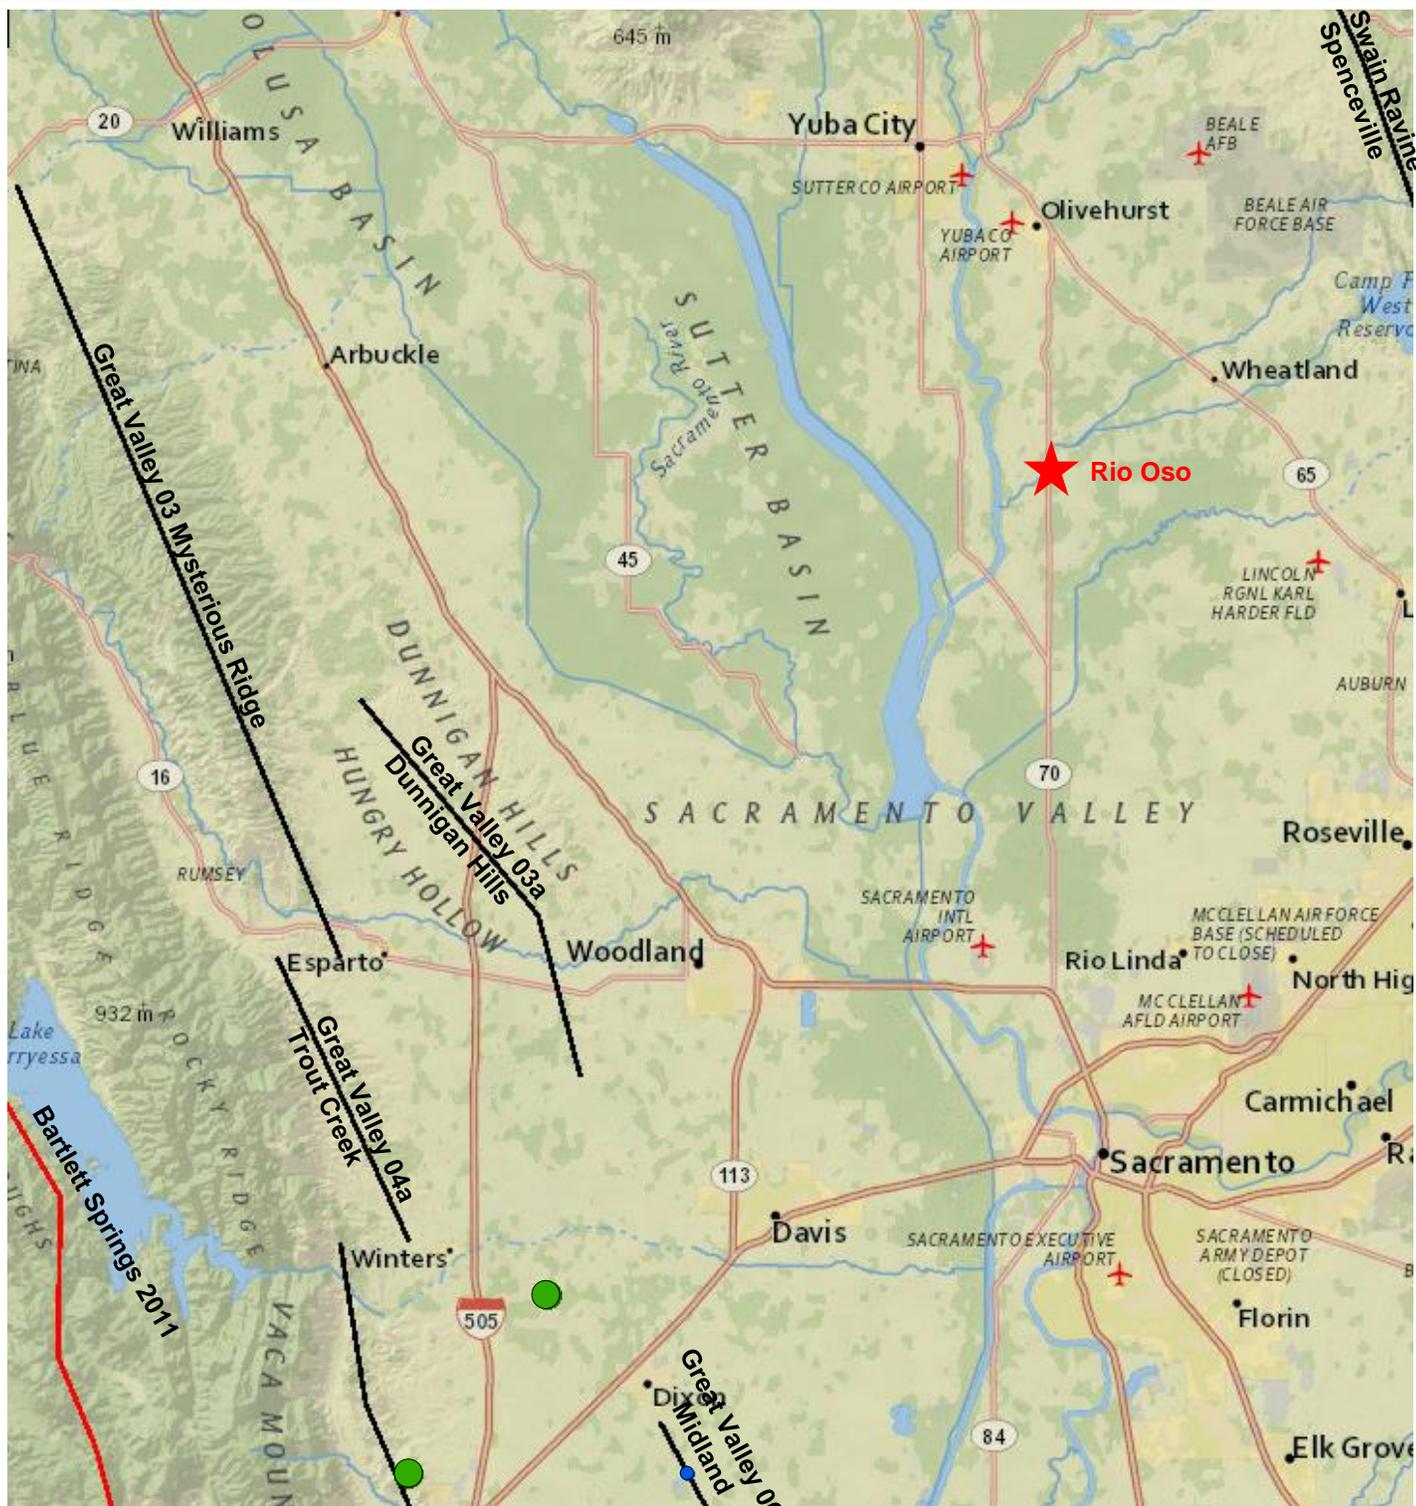
Fault Map
July 2019 FIGURE 4

- ★ Project Location
- Historic Earthquake Magnitude 5-6
- Historic Earthquake Magnitude 6-7
- Thrust Fault
- Strike Slip Fault

The closest fault to the project within the GVFZ is the Dunnigan Hills Fault. The Dunnigan Hills fault is Quaternary active fault with a slip rate best estimate of 0.6 mm/yr and a maximum magnitude of 6.5 (Field et al., 2013). The closest fault to the project within the Foothills fault system in the Swain Ravine – Spenceville fault with a slip rate best estimate of 0.05 mm/yr and a maximum magnitude of 6.5 (Anderson and Ake, 2008). Due to the very low slip rates, the impact of hazard from the Foothills fault system is low. A fault map showing the project locations and earthquake events is included as Figure 4 – Fault Map.

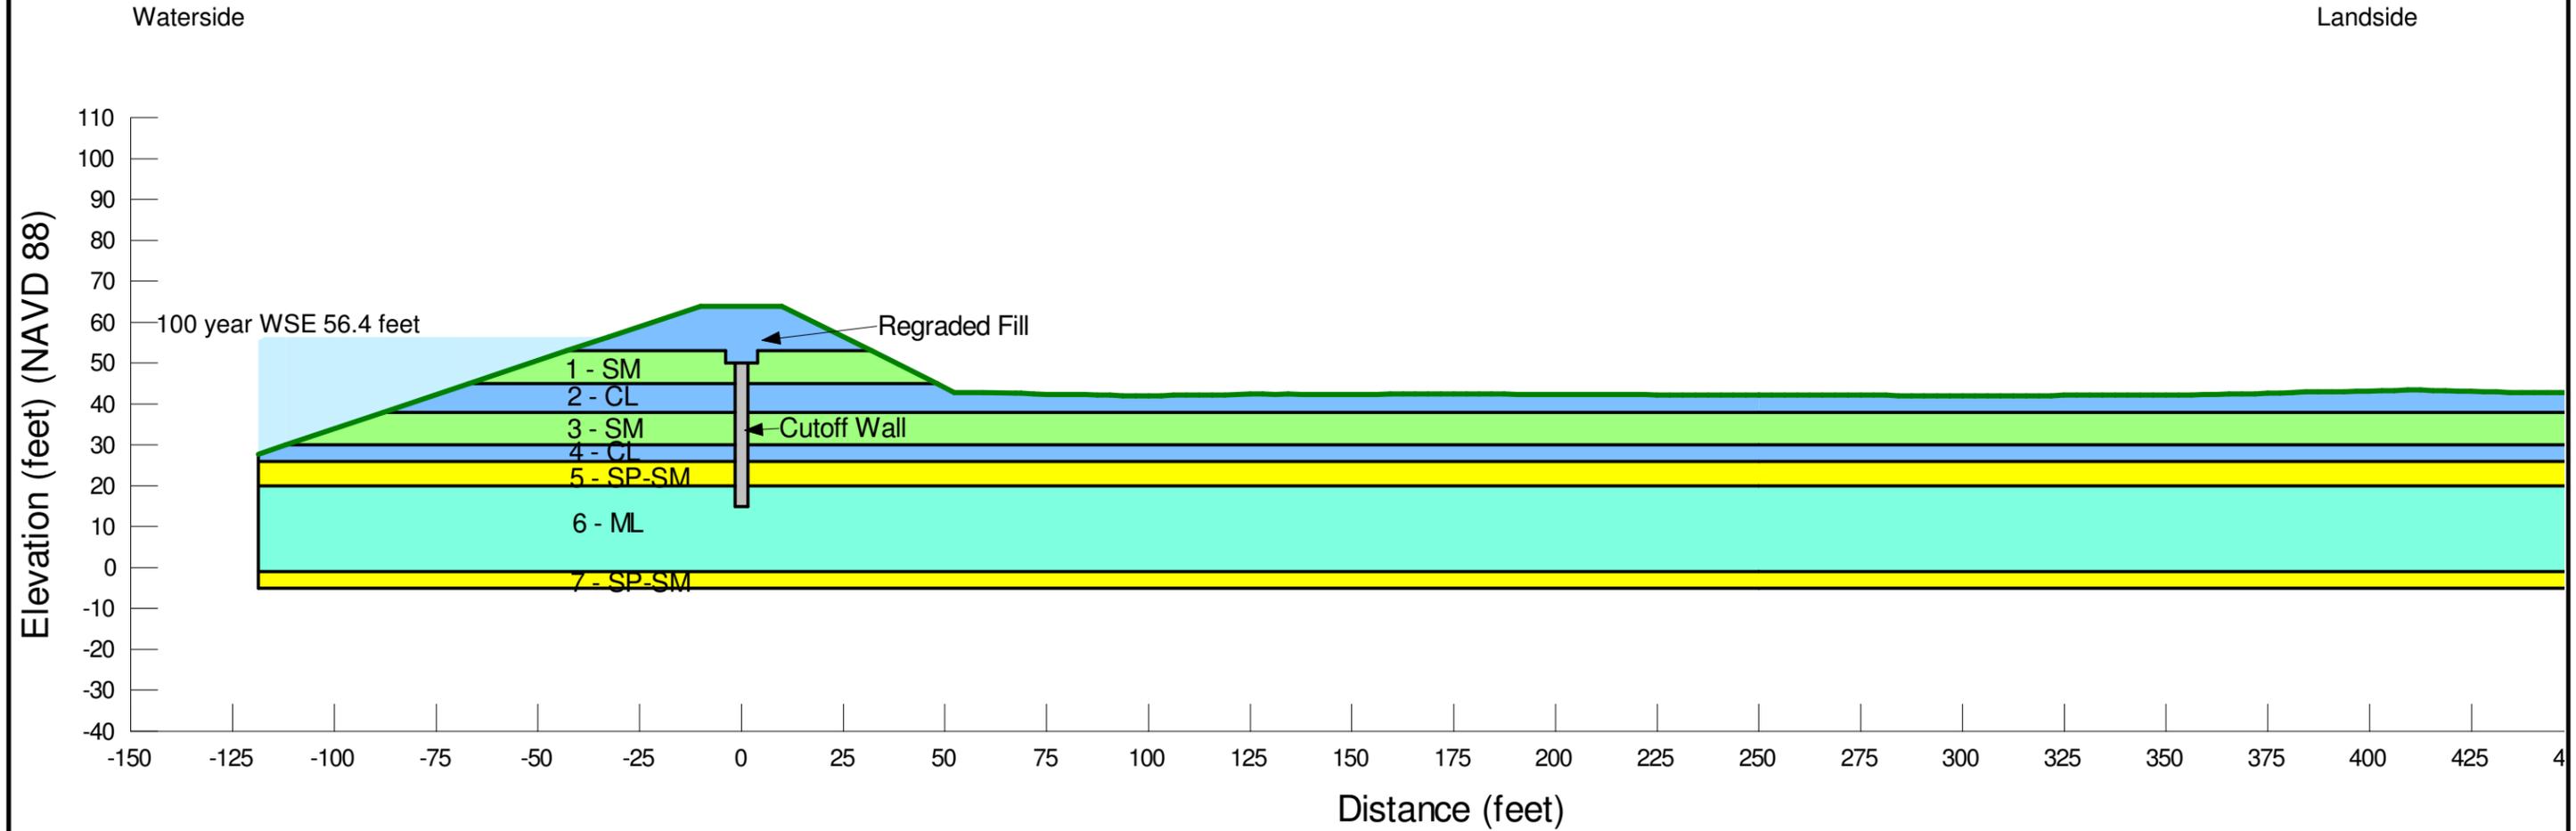
Reach B (BR-L 1106+12)

Layer	Material	Total Unit Weight (pcf)	Shear Strength			
			C' (psf)	Φ' (deg)	C (psf)	Φ (deg)
1	SM	125	0	33	-	-
2	CL	120	100	31	360	4
3	SM	125	0	32	-	-
4	CL	120	100	31	360	4
5	SP-SM	125	0	34	-	-
6	ML	120	50	31	360	4
7	SP-SM	125	0	34	-	-
Regraded Fill	CL	125	100	31	360	4
Cutoff Wall	SCB	120	500	0	500	0

Segment 283 Reach B (BR-L 1106+12) Cutoff Wall Half Levee Degrade Slope Stability Model
			Aug 2019
